DECISION NOTICE ADOPTION OF EXISTING ENVIRONMENTAL REVIEW

Central Post and Treating Company CECRA Facility: Phase II, Capping and Site Reclamation
September 2022
City of Lewistown
47.076771, -107.406673
Fergus County

Existing Environmental Review Document: Tetra Tech Voluntary Clean Up Plan for Montana
Department of Environmental Quality – Environmental Assessment

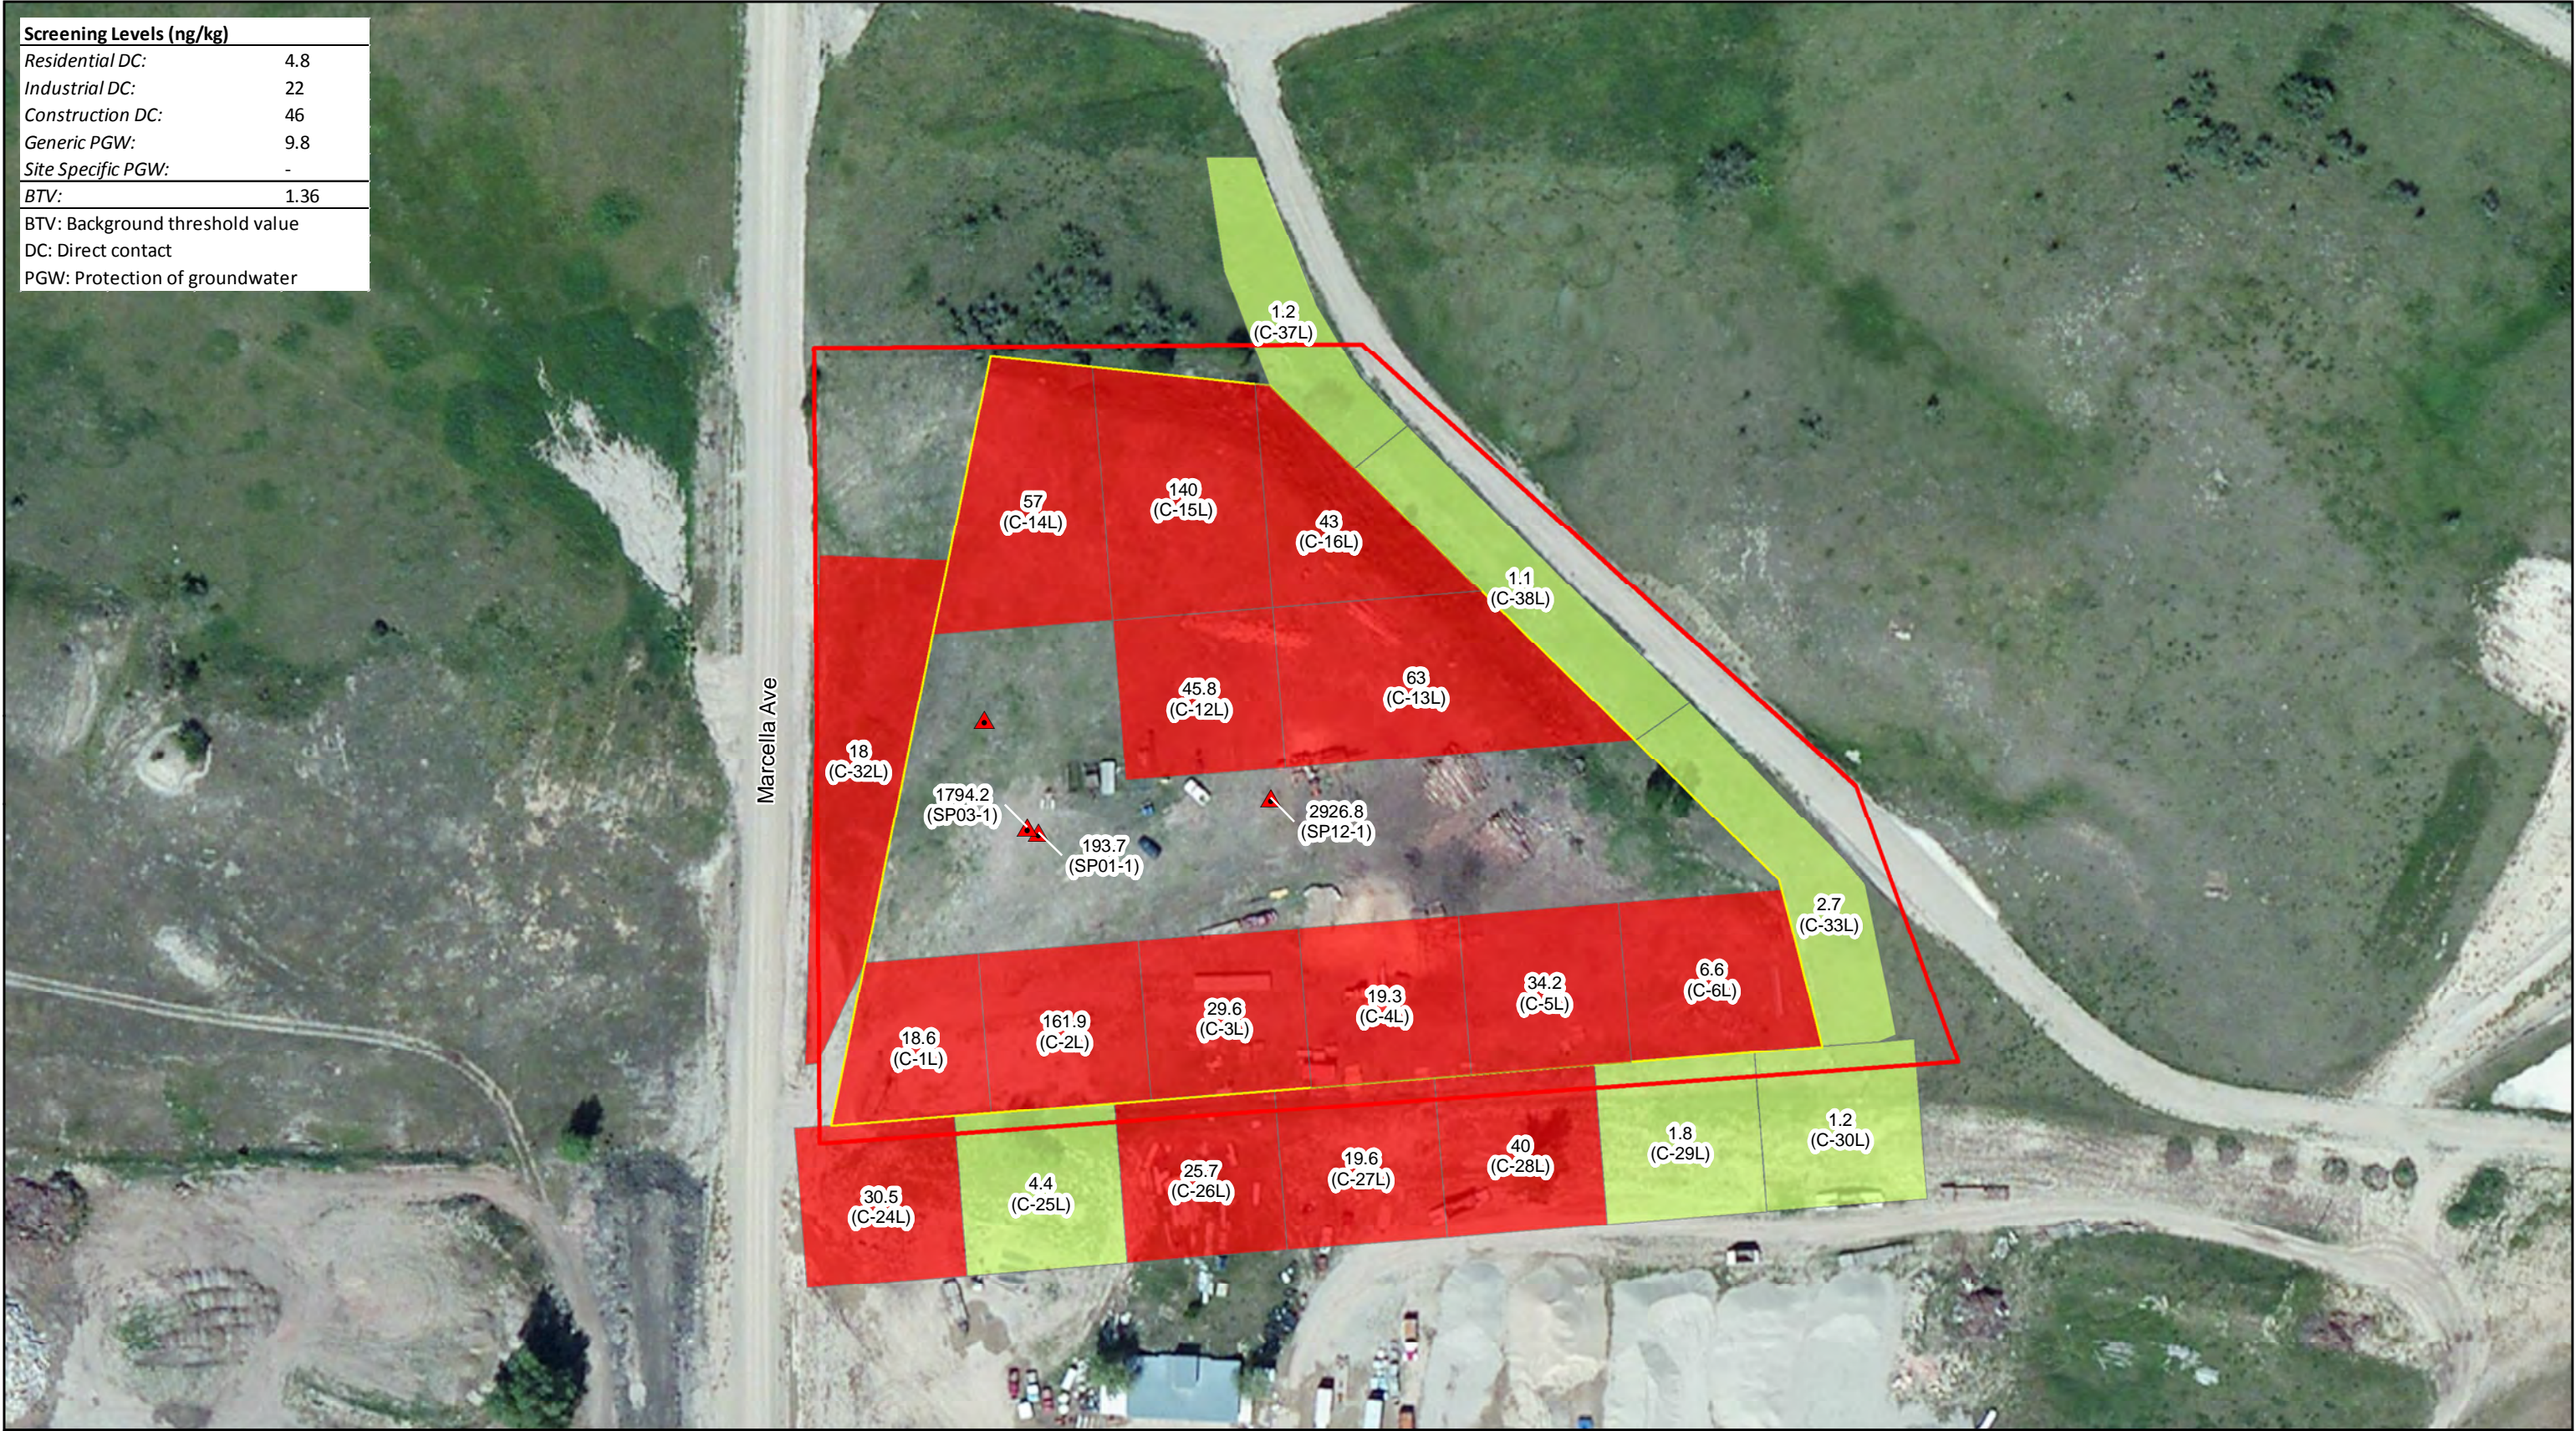
Screening Levels (ng/kg)	
Residential DC:	4.8
Industrial DC:	22
Construction DC:	46
Generic PGW:	9.8
Site Specific PGW:	-
BTV:	1.36
BTV: Background threshold value	
DC: Direct contact	
PGW: Protection of groundwater

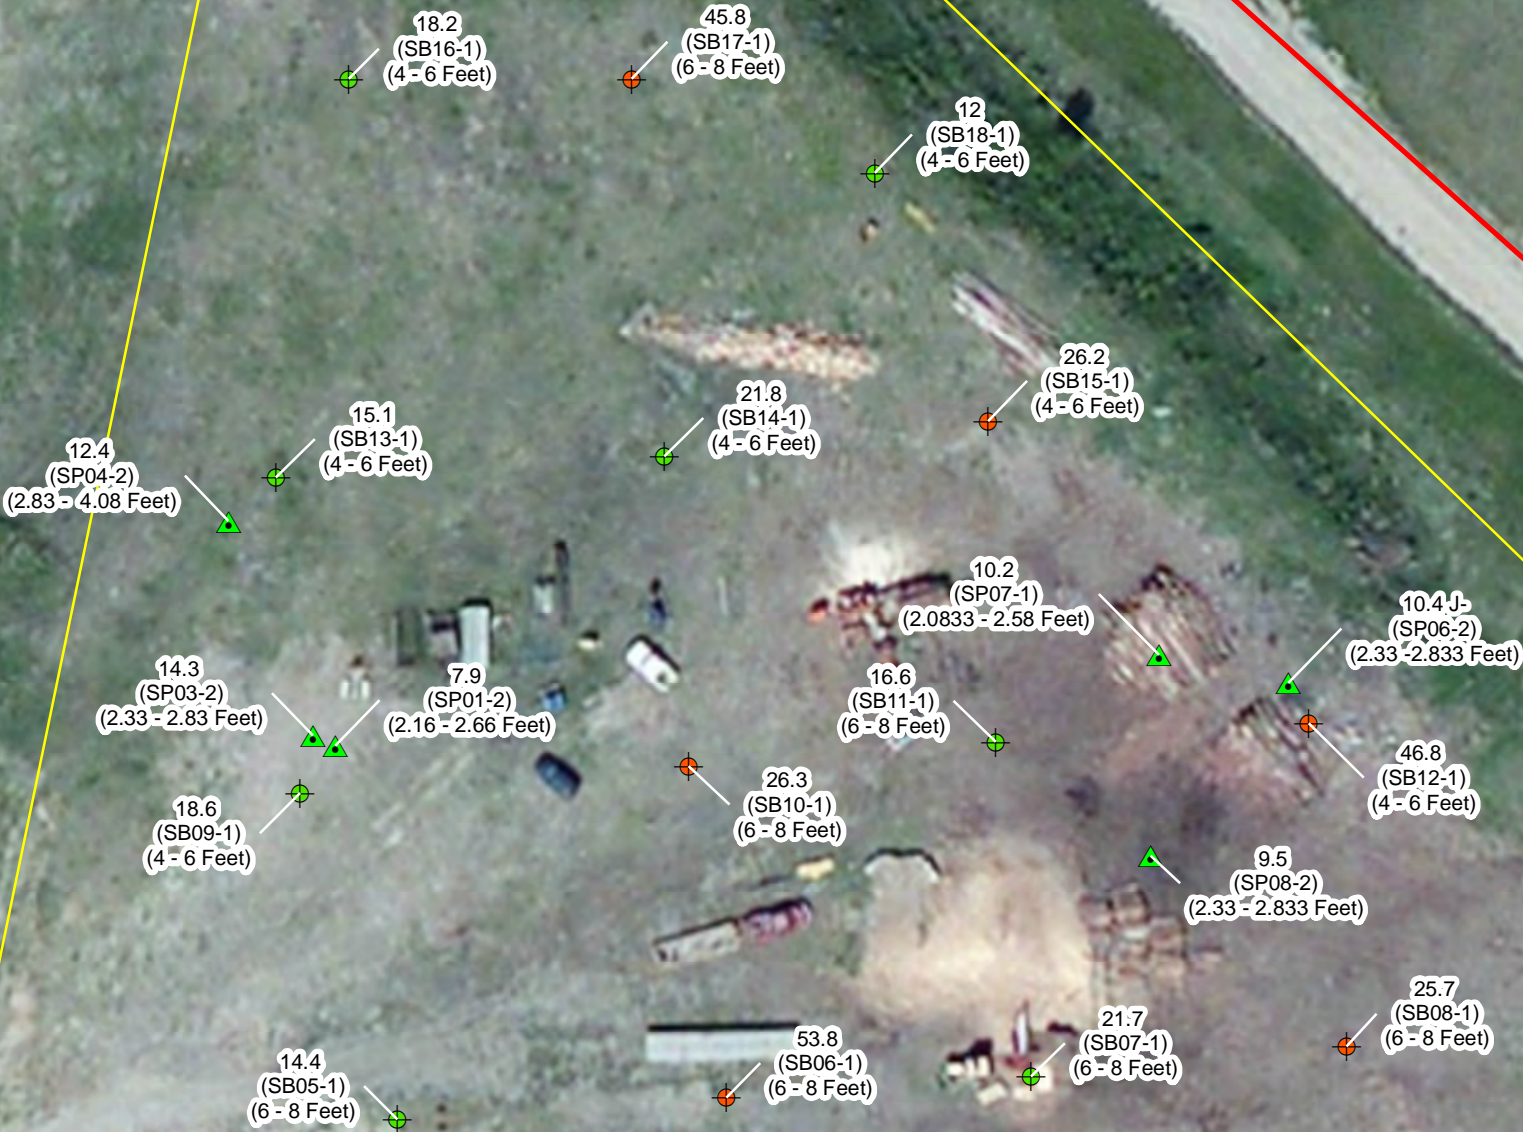
Screening Levels (mg/kg)	
Construction DC:	19.5
Generic PGW:	2.9
Site Specific PGW:	0.015
BTV:	22.5
BTV: Background threshold value	
DC: Direct contact	
PGW: Protection of groundwater

LEGEND			
Soil Boring (Results in mg/kg)		Soil Excavation Pit (Results in mg/kg)	
	Result less than background threshold value		Result less than background threshold value
	Result greater than background threshold value		Result greater than background threshold value
	Landfill Extent		Property Boundary
(SB05-1)	Sample ID	(6 - 8 Feet)	Sample Depth Below Ground Surface
mg/kg	Milligrams per kilogram

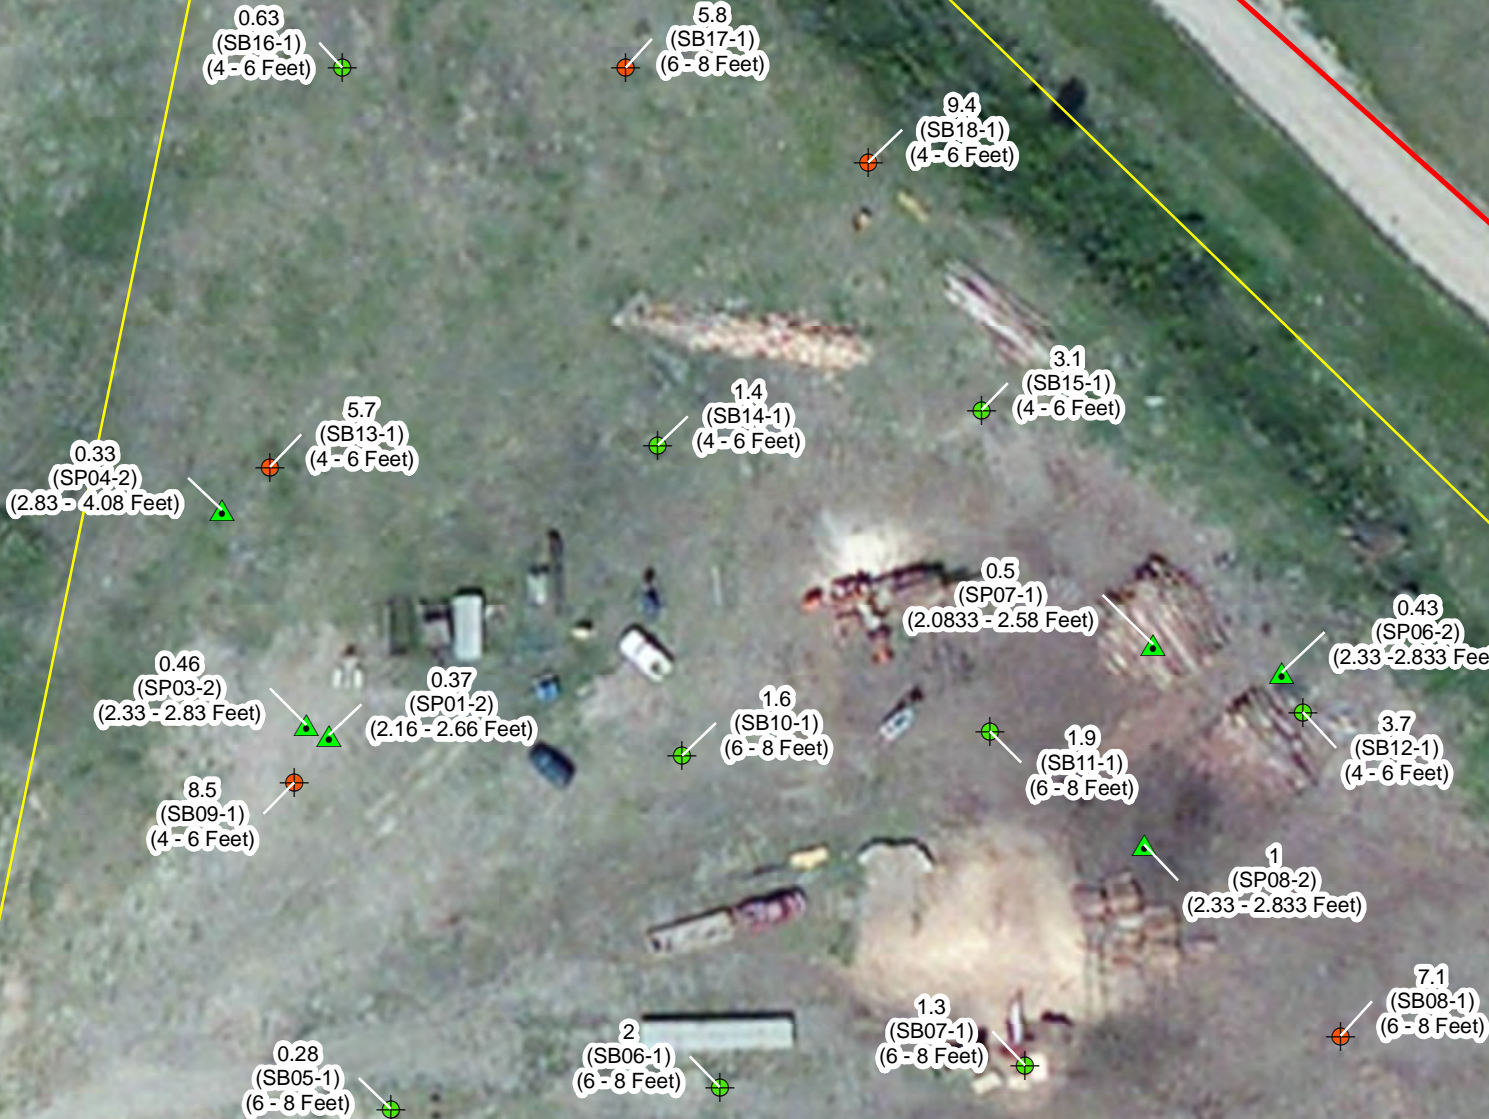
Screening Levels (mg/kg)	
Construction DC:	2090
Generic PGW:	3.8
Site Specific PGW:	21
BTV:	0.7
BTV: Background threshold value	
DC: Direct contact	
PGW: Protection of groundwater

LEGEND			
Soil Boring (Results in mg/kg)		Soil Excavation Pit (Results in mg/kg)	
	Result less than generic PGW screening level		Result less than generic PGW screening level
	Result greater than generic PGW screening level		Result greater than generic PGW screening level
			Landfill Extent
			Property Boundary
		(SB05-1)	Sample ID
		(6 - 8 Feet)	Sample Depth Below Ground Surface
		mg/kg	Milligrams per kilogram
		PGW	Protection of groundwater

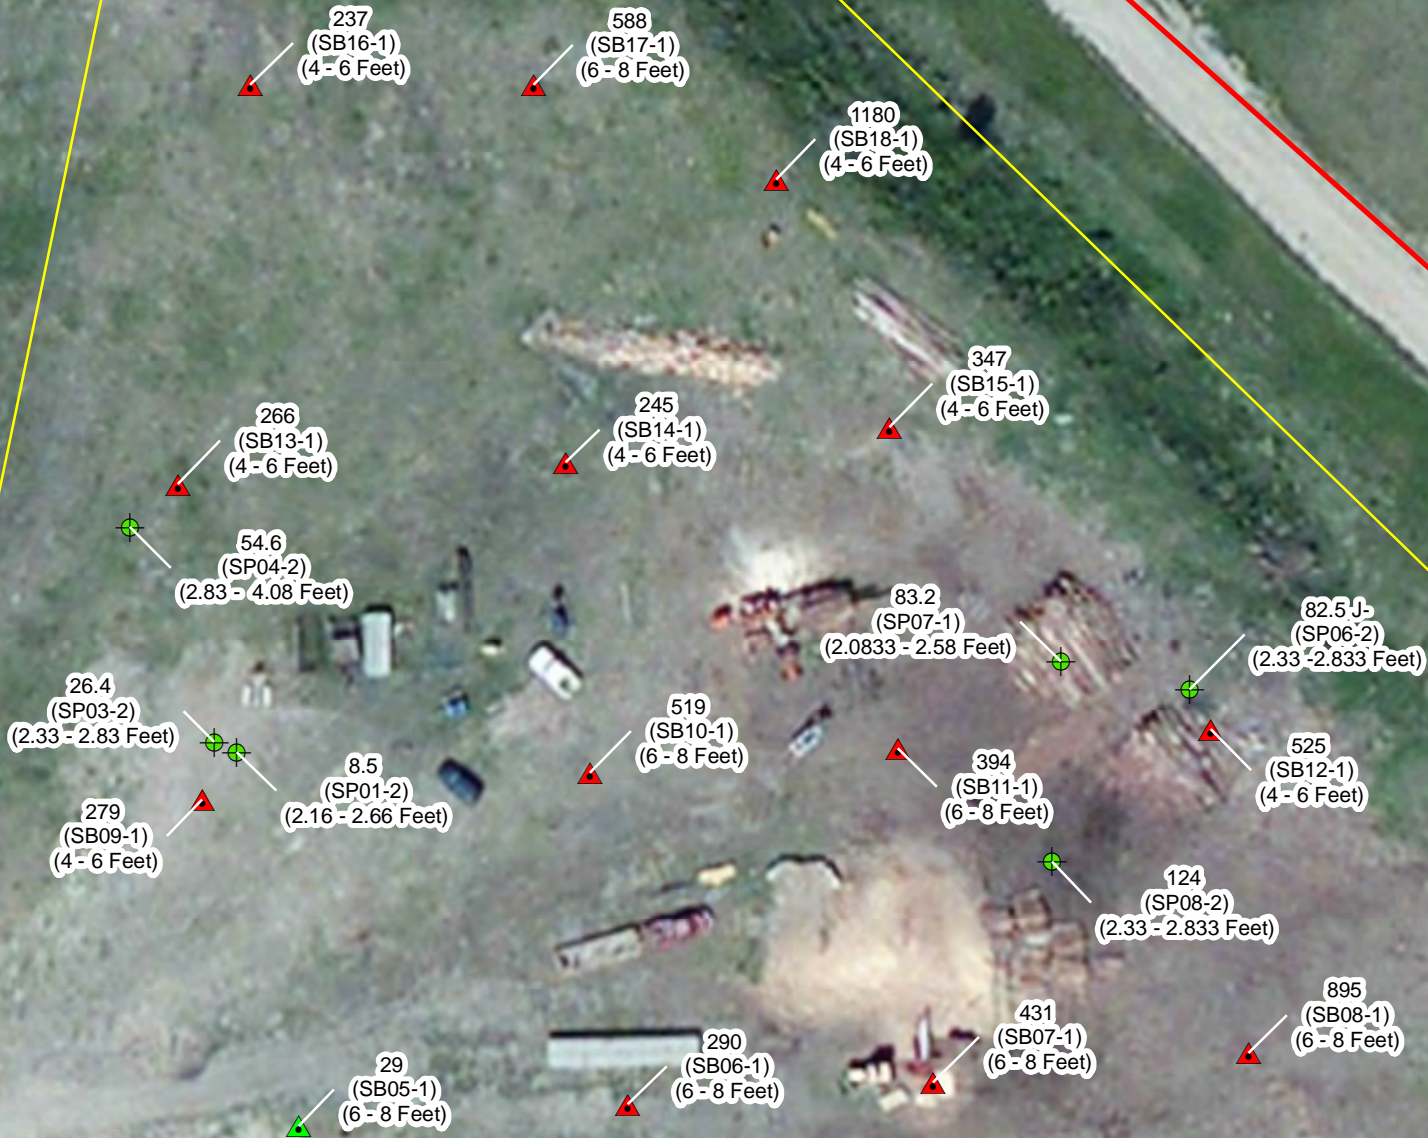
Screening Levels (mg/kg)	
Construction DC:	153
Generic PGW:	140
Site Specific PGW:	478
BTV:	29.8
BTV: Background threshold value	
DC: Direct contact	
PGW: Protection of groundwater

Soil Boring (Results in mg/kg)		Soil Excavation Pit (Results in mg/kg)		Landfill Extent		(6 - 8 Feet) Sample Depth Below Ground Surface	
	Result less than generic PGW screening level		Result less than generic PGW screening level		Landfill Extent	mg/kg	Milligrams per kilogram
	Result greater than generic PGW screening level		Result greater than generic PGW screening level		Property Boundary	PGW	Protection of groundwater
				(SB05-1)	Sample ID	J-	Result is considered estimated and is biased low

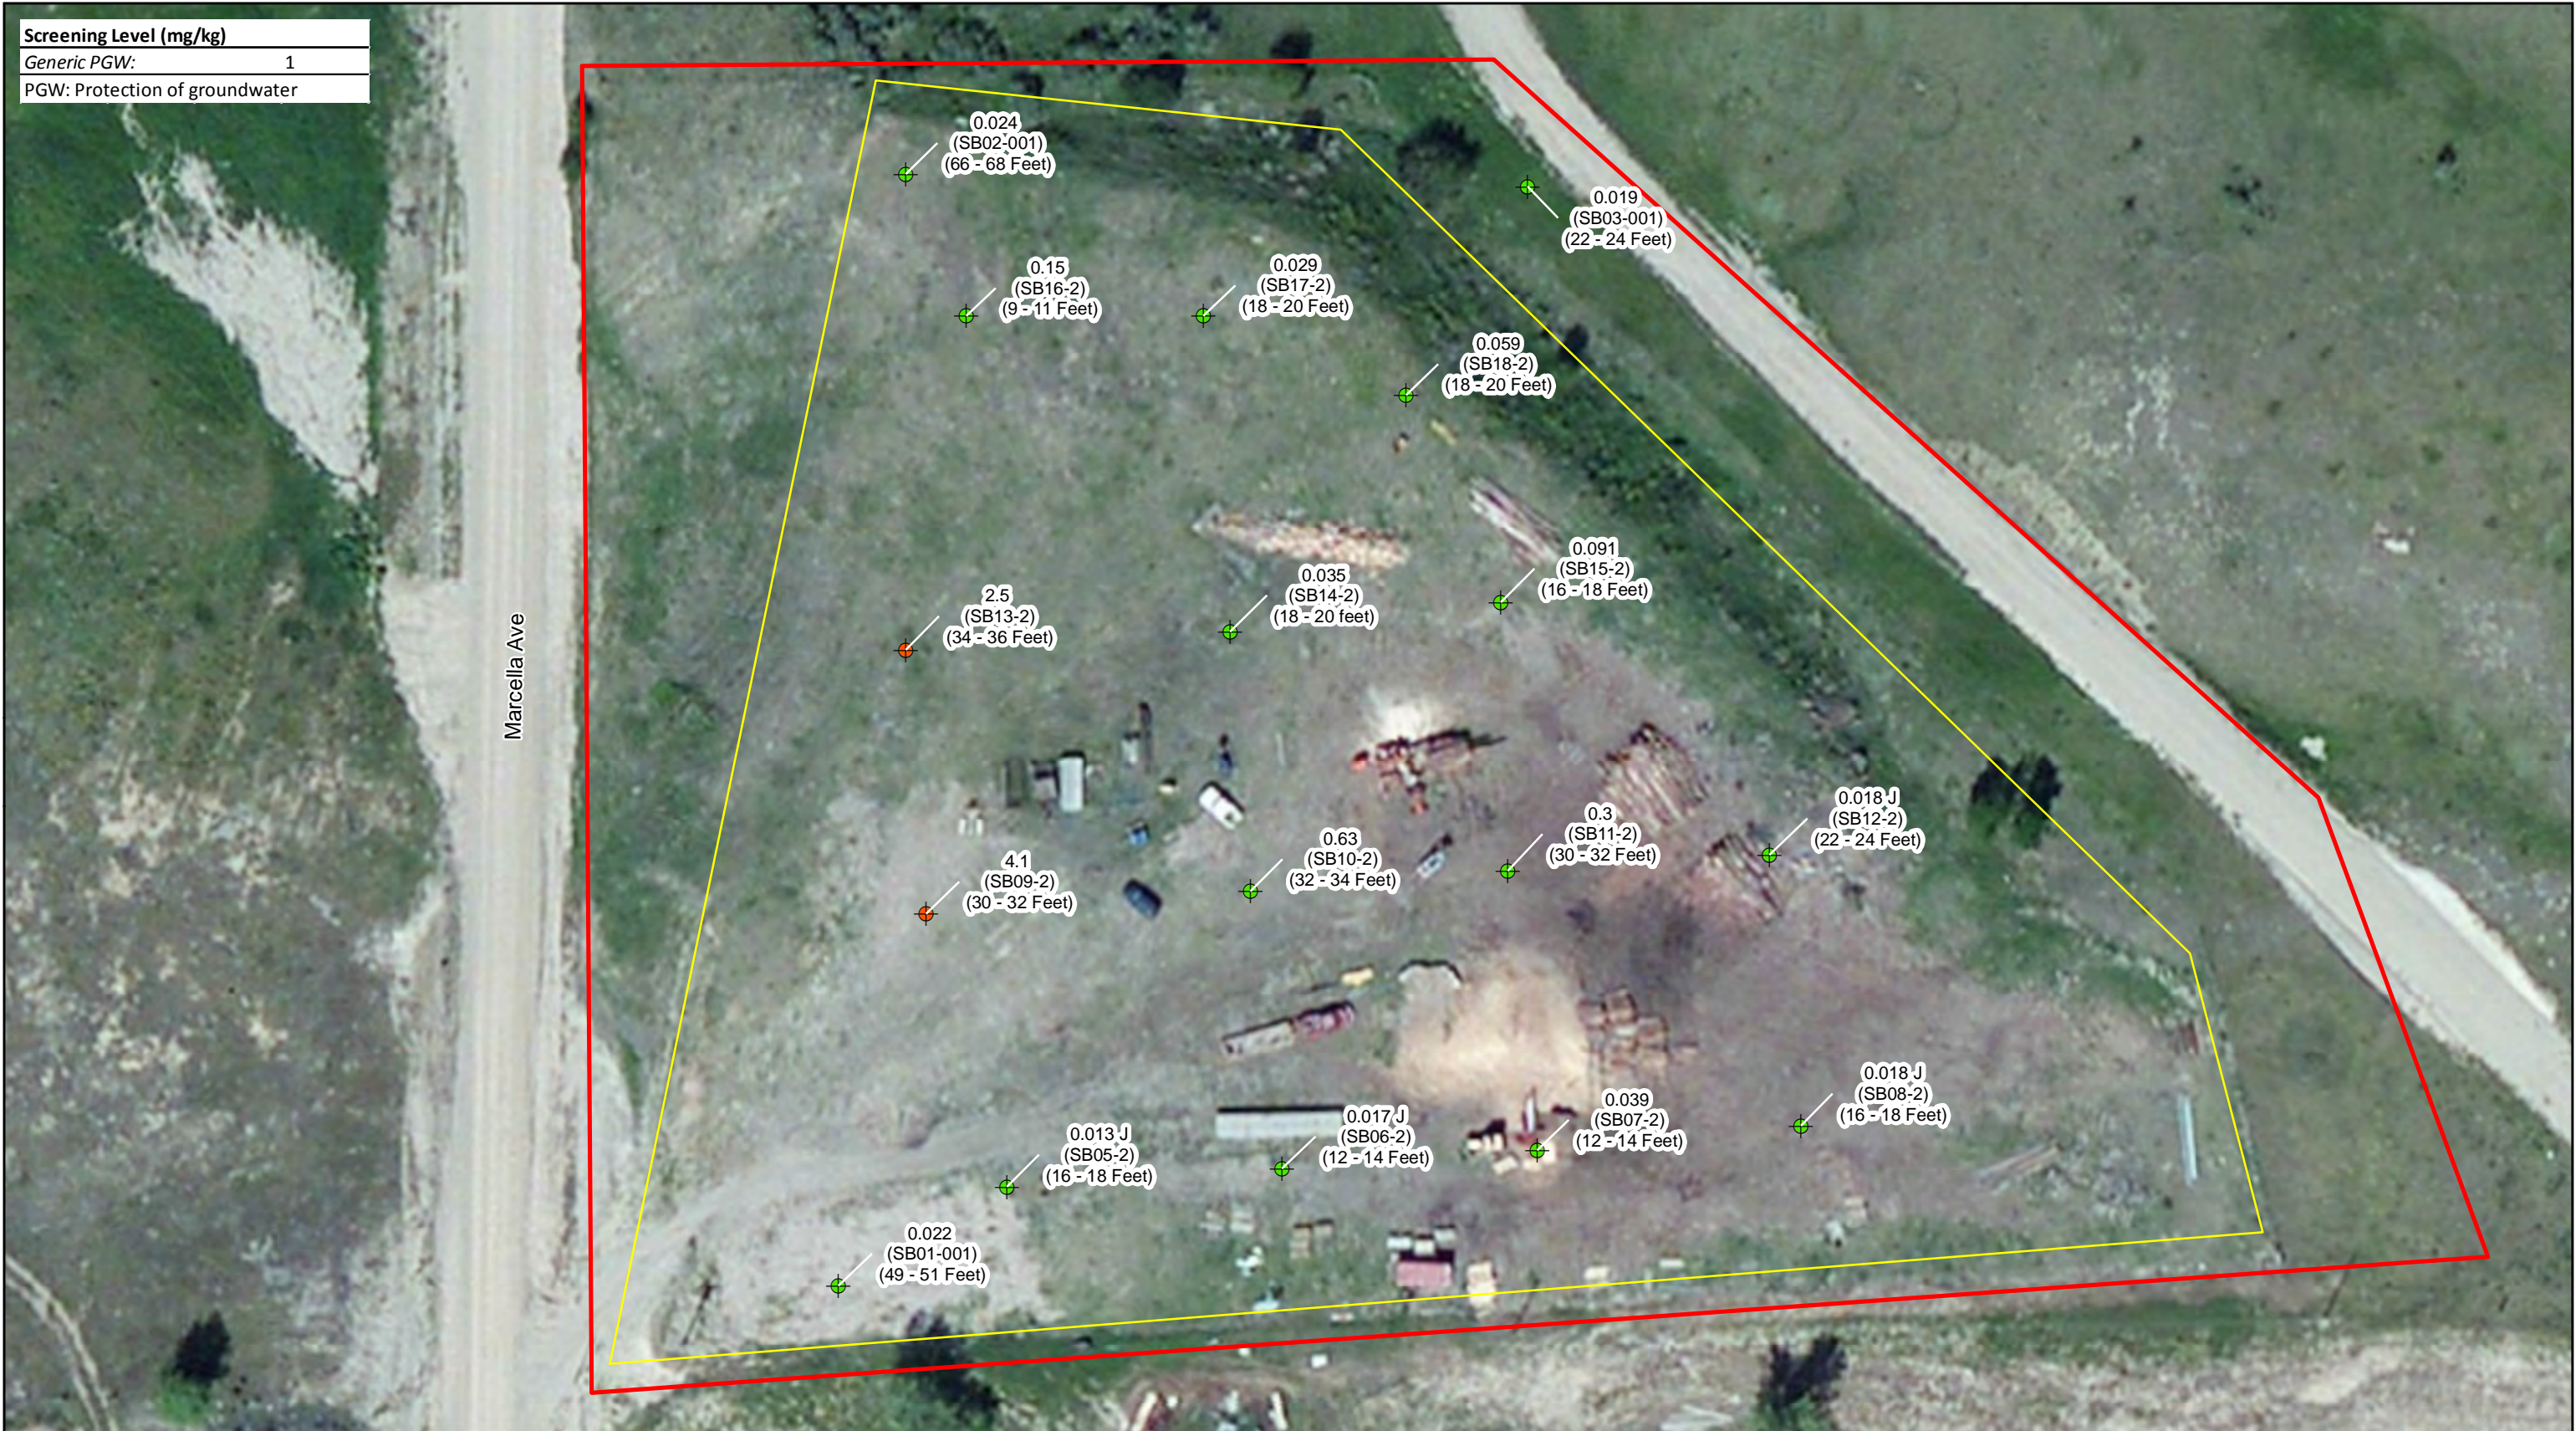
Screening Level (mg/kg)	
Generic PGW:	1
PGW: Protection of groundwater

LEGEND			
Soil Boring (Results in mg/kg)			
	Result less than generic PGW screening level		Landfill Extent
	Result greater than generic PGW screening level		Property Boundary
		(SB05-2)	Sample ID
		(16 - 18 Feet)	Sample Depth Below Ground Surface
		J	Value is estimated
		mg/kg	Milligrams per kilogram
			PGW Protection of groundwater

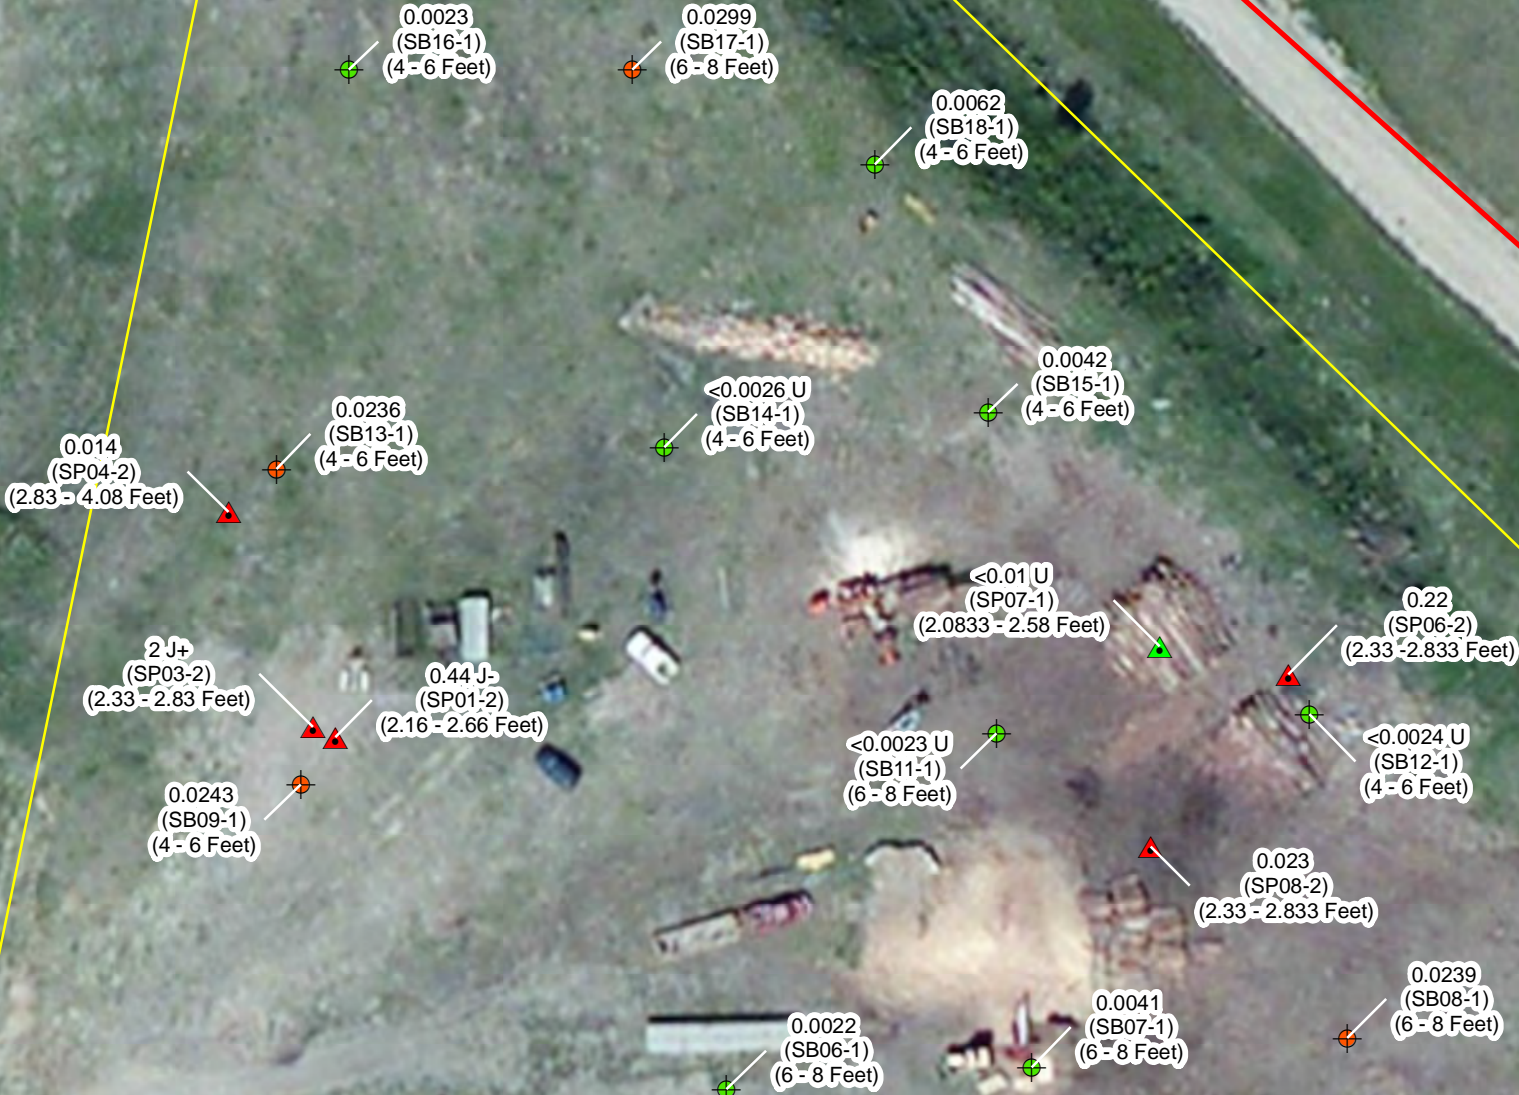
Screening Levels (mg/kg)	
Construction DC:	77
Generic PGW:	0.014
Site Specific PGW:	3.56
DC: Direct contact	
PGW: Protection of groundwater

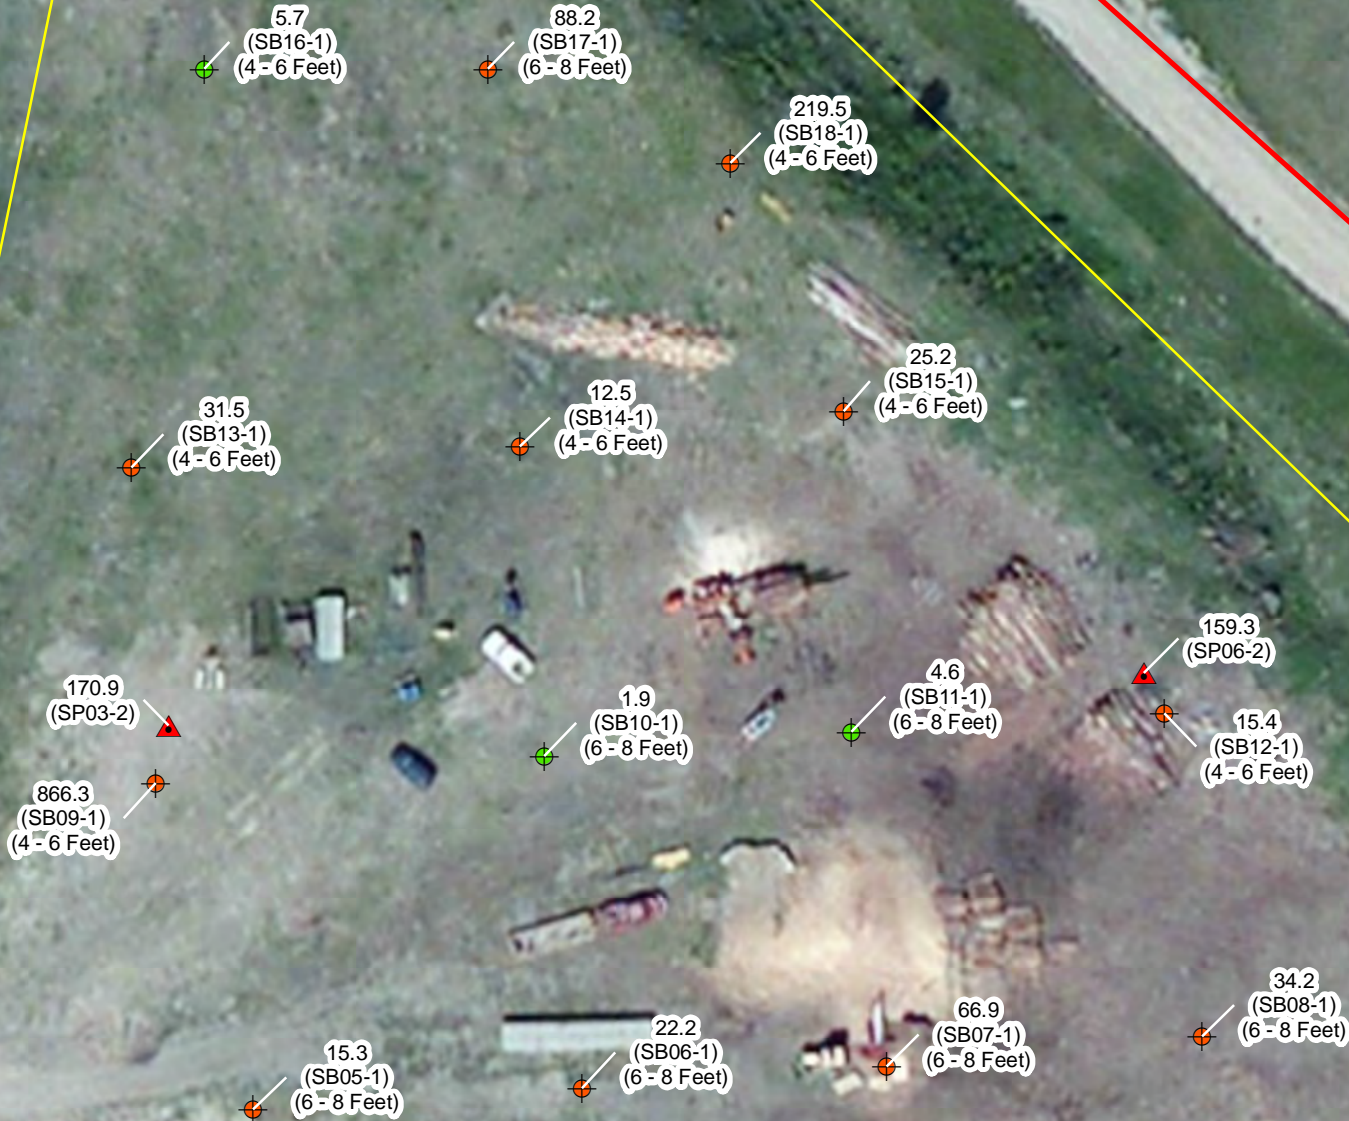
FIGURE 33
DIOXIN AND FURANS (2 - 10 FEET)
SUBSURFACE SOILS

Screening Levels (ng/kg)	
BTV:	1.36
Industrial DC:	22
Construction DC:	46
Generic PGW:	9.833333
Site Specific PGW:	-
BTV: Background threshold value	
DC: Direct contact	
PGW: Protection of groundwater
